KYOVA 5th Street West Bridge Study Report

City of Huntington
Cabell County, West Virginia

Prepared by AECOM Technical Services, Inc.

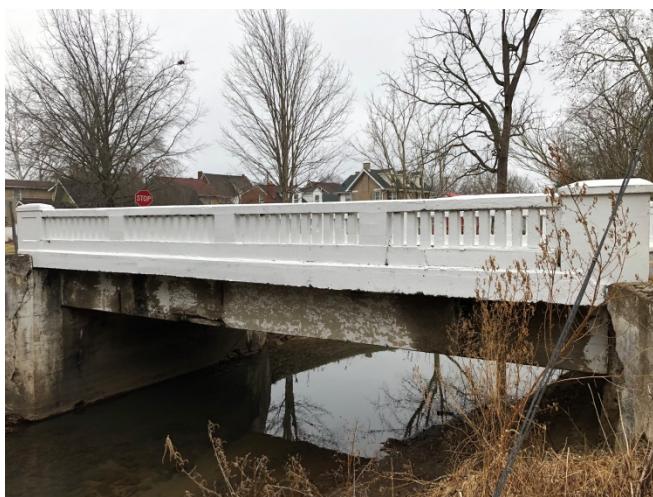
Figure 3: 5th Street West Bridge General Elevation

The bridge was built in 1921. The sufficiency rating as supplied by the WVDOH is 41.0. The bridge has not undergone any major reconstruction; however, the bridge is posted for a 10-ton weight restriction. The bridge is a single span, simply supported reinforced concrete T-Beam system with a span length measuring 41.7 feet. The floor system of the bridge is in poor condition, consisting of numerous areas of advanced spalling with exposed rebar, cracking, delamination, and scaling. The bridge has a reinforced concrete balustrade type parapet wall along each side that contains scattered cracking, delamination, and spalling. The overall length, measured from end to end of parapet walls, is 43.6 feet. The curb to curb roadway width is 24.1 feet and the out-to-out width of the superstructure is 27.2 feet.

The span is supported by two reinforced concrete abutments at the ends with full height wingwalls. Both abutments are in poor condition, containing advanced spalling, cracking, and delamination. Though there is no undermining or scour present at the abutments, there is stream bank erosion present downstream.

The bridge is a straight structure, not containing any skew. The existing structure contains an 8-inch thick reinforced concrete deck that is in poor condition and a 3-inch thick asphalt wearing surface. Advanced spalling with exposed rebar and chloride leaching are found on the underside of the concrete deck. The asphalt wearing surface is in fair condition with some transverse cracking and potted areas at the ends of the structure.

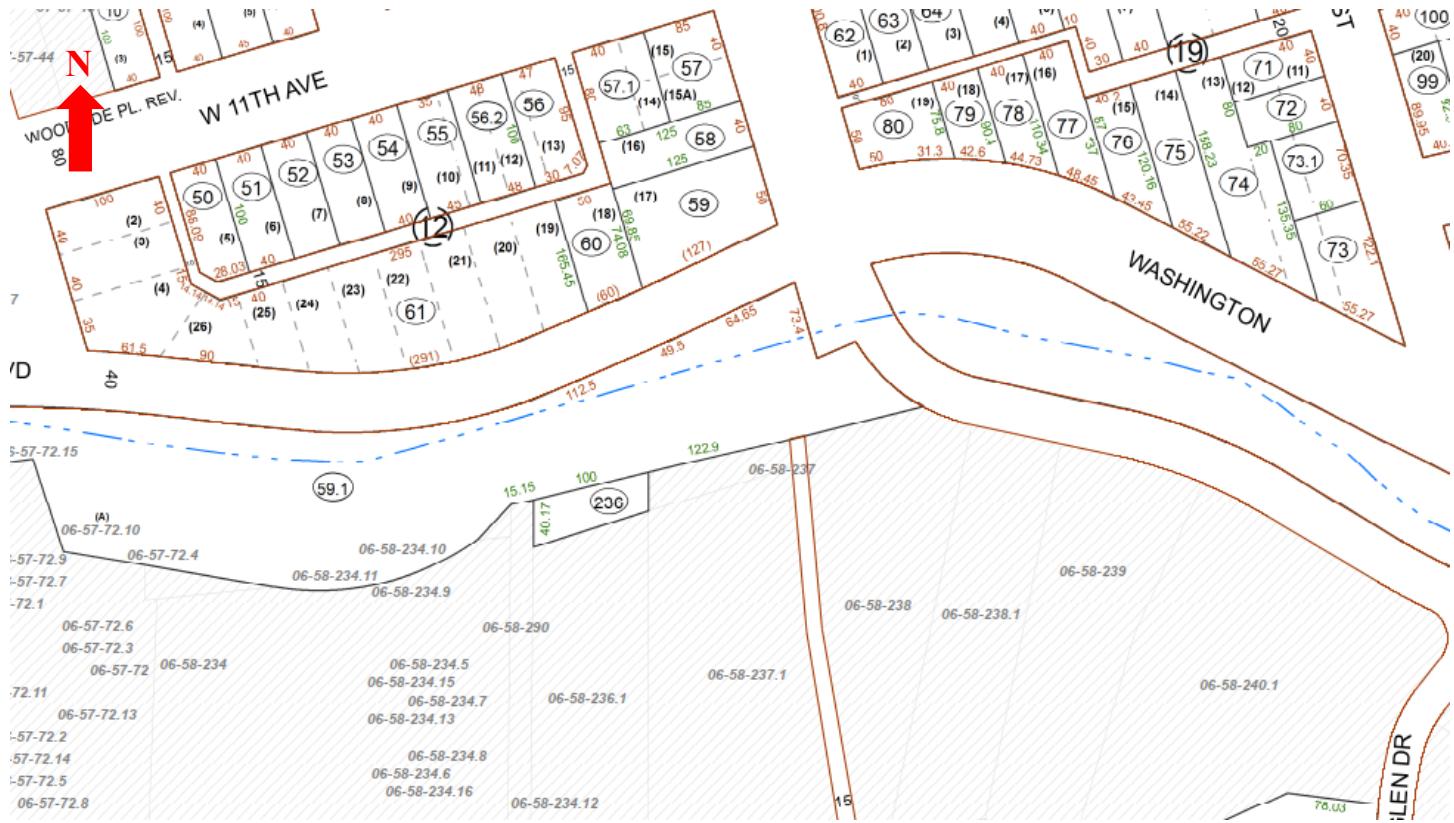
Figure 4: 5th Street West Bridge Project Site Tax Map

There was no existing right-of-way information distributed at the time of this report. Property lines were identified based on the Huntington-Kyle Corp Tax Map Sheet 58. Figure 4 shows an overview of the surrounding property parcels relative to the project site, according to the referenced Tax Map.

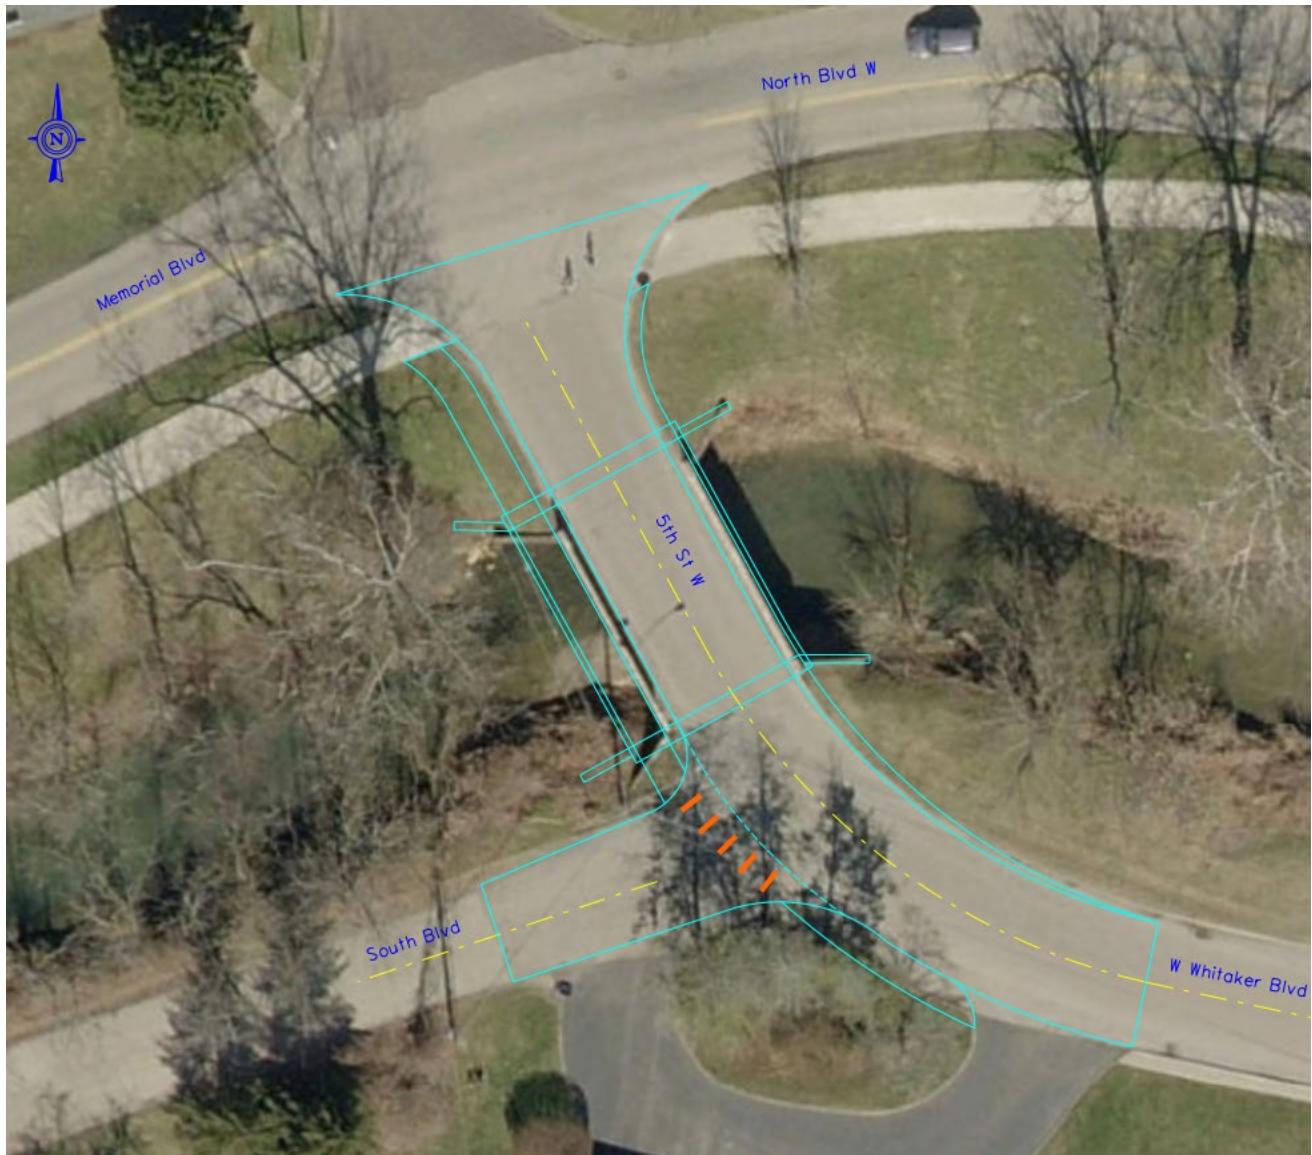
Figure 5: 5th Street West Bridge Replacement Alternative

The Replacement Alternative, as shown in Figure 5 below, will require the construction of a new bridge with a single span length of approximately 51 feet and a clear width of 28 feet, consisting of two 11-foot lanes and 3-foot shoulders on each side of the roadway and uses the existing alignment of 5th Street West. The proposed bridge will also include a 6-foot sidewalk along the western side, which is to be tied into the existing trail crossing along 5th Street West. By also proposing new additional sidewalk along the western side of West Whitaker Boulevard as well as a crosswalk crossing South Boulevard, pedestrians in the surrounding residential area will be able to better access the walking trail north of the bridge along Memorial Boulevard and North Boulevard West.

Because of the proposed sidewalk and shoulders, the out-to-out width of the bridge will be widened by approximately 10 feet. Based off aerial mapping, doing so will require lengthening the bridge span from approximately 43.5 feet to 51 feet to avoid placing the western end of the proposed north abutment in the stream channel. Monumental balustrades will be provided along the sides of the bridges to restore the historical integrity of the existing bridge and surrounding area and will also match similar railing used on the proposed replacement of the 8th Street Bridge further downstream. The vertical alignment of the proposed superstructure will be similar to the existing bridge's vertical alignment by incorporating beams with a similar depth to the existing beams. To meet current design standards, an 8.5-inch deck is proposed and will be designed to accommodate a future wearing surface. The Replacement Alternative was found to be a prudent alternative.

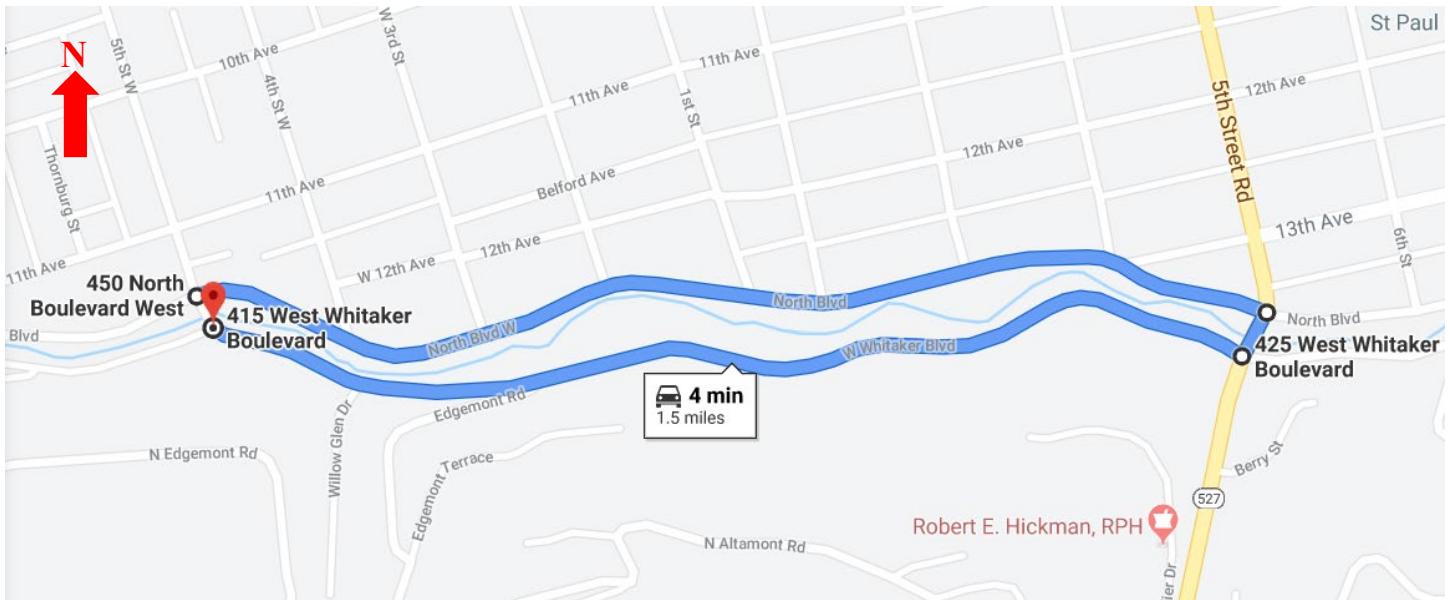
Figure 6: 5th Street West Bridge Detour Route

Due to the narrow width of the existing bridge, both the Rehabilitation and the Replacement Alternatives would require a detour to reroute traffic during construction. The most feasible detour route to avoid significant inconveniences to traffic flow is to use of the 5th Street Bridge to cross Fourpole Creek to access both North Boulevard West and West Whitaker Boulevard. Figure 6 below shows the proposed detour route for the construction of 5th Street West Bridge.

There was a consensus with the Stakeholder group that Whitaker Boulevard provides an obvious detour to the improved 5th Street East Bridge, that will be replaced with an improved, wider structure, prior to the 5th Street West Bridge construction. Stakeholders did not think that the added cost for phased construction or a temporary bridge was warranted.
